INVESTIGATING THE CAUSAL LINK BETWEEN LIGHTNING STRIKES, CSST AND FIRE

Mark Goodson PE
Mark Hergenrether, MSME

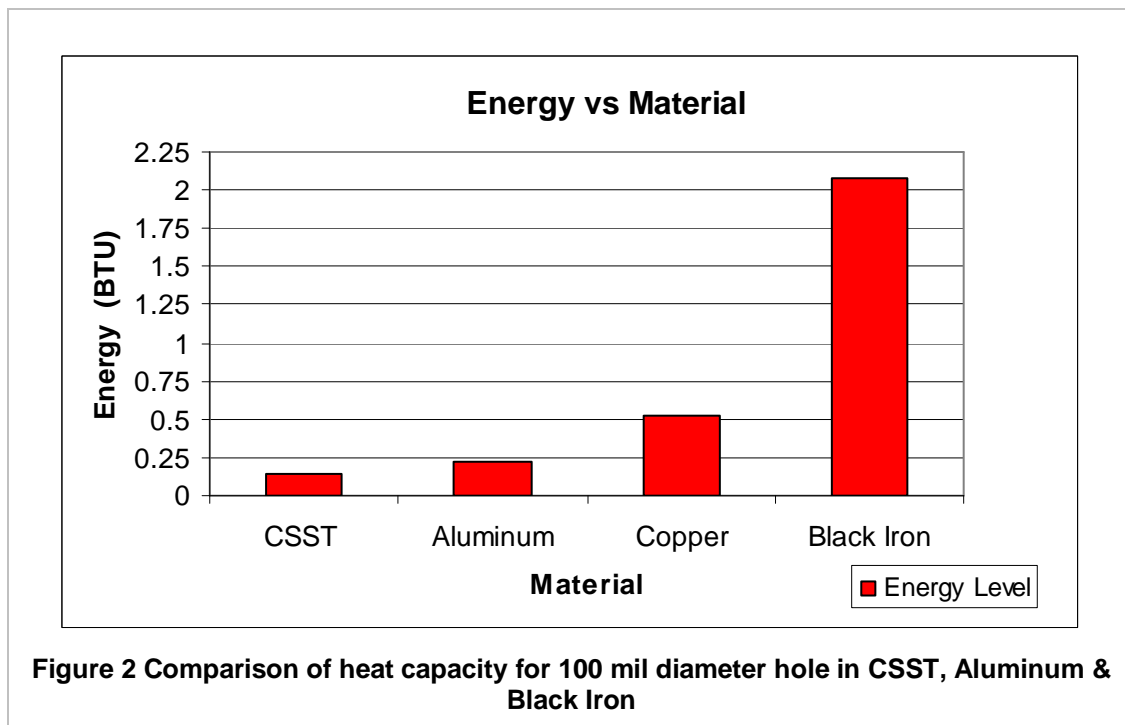
For an equivalent 100-mil diameter hole, we can calculate the values for heat capacity based on the aforementioned equation. Figure 2 is a plot of the

respective values for each material. The amount of energy to create a 100-mil diameter hole is much greater for black iron pipe than for any of the other three specimens. See Figure 2. Thus, the thickness of the black pipe is critical to prevent fires post lightning strike. In fact for this particular case, the amount of energy for a conventional 1/2" black pipe will require ~15 times which would be required to similarly melt CSST.

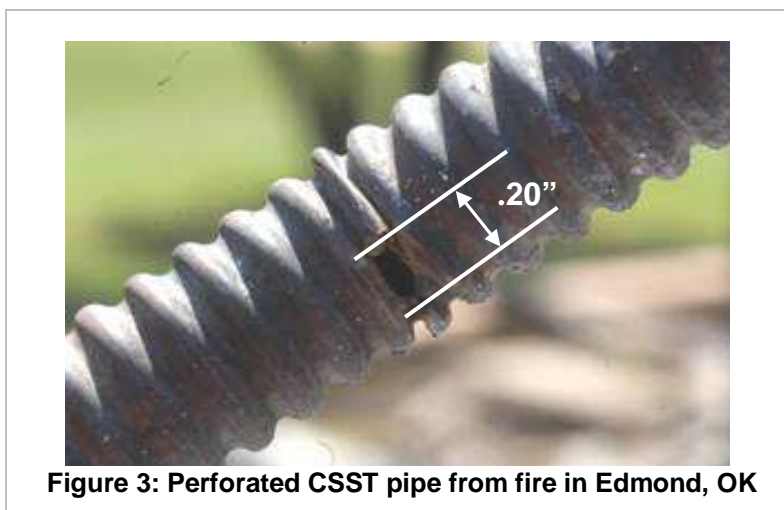
Figure 3: Perforated CSST pipe from fire in Edmond, OK

The fire occurred in a two story house under construction, plumbed with approximately 95% black pipe with a value in excess of \$1,000,000. Two runs of CSST, each serving a metal chimney, comprised the CSST piping in the house. A perforation with its major axis measuring approximately 200 mils was found in the CSST; this is shown in Figure 3. A positive lightning report was obtained, showing 11 strikes within 0.5 mile. Figure 4 shows the failed CSST run to the fireplace.

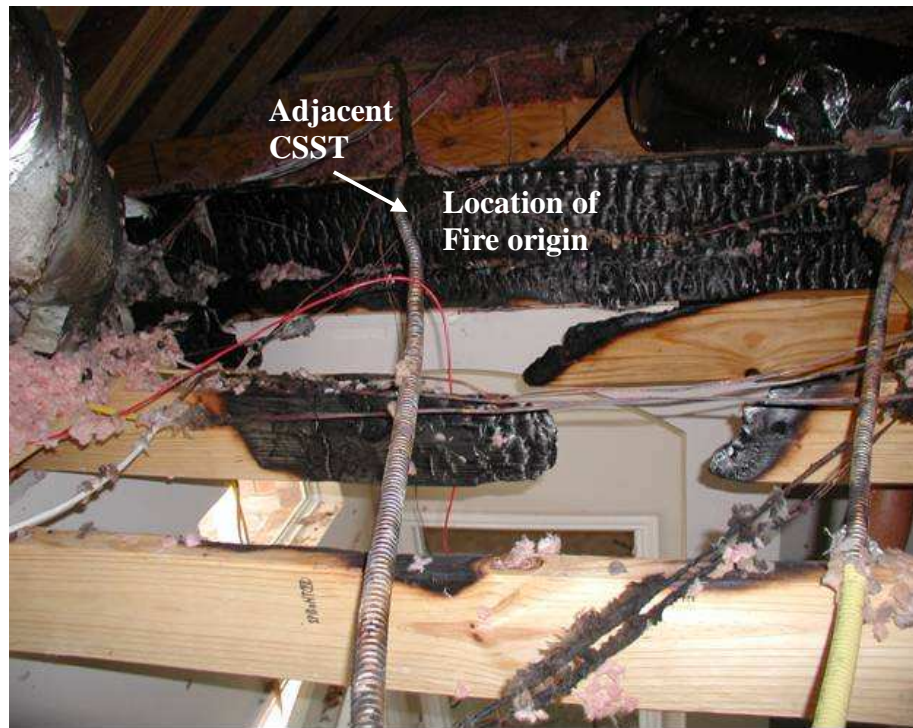
Figure 5: Attic fire during lightning storm Cedar Hill, TX.

The fire occurred within the attic space of a home, which included several runs of CSST. The CSST runs went to a fireplace, furnace, range, and water heater. During a lightning storm, the CSST run serving the fireplace leaked and the resultant fire then destroyed a section of the attic. A perforation measuring 95 mils along its major diameter was found in the pipe. A lightning report showed that there were approximately 5 strikes within 0.3 mile of the house. The fire was contained within the attic, but subjected the house to extensive smoke damage. Figure 5 shows the burned section of the attic as a result of the fire that occurred during the lightning storm. Figure 6 shows a view of the arc site of this same failed CSST when viewed under a Scanning Electron Microscope (SEM).

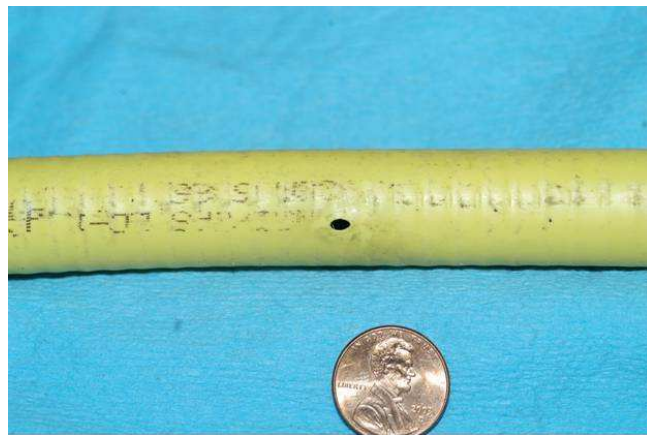
Figure 7: Photo of perforated CSST without pyrolysis

To find holes, we recommend an instrumented leak test at ~ 7" WC air. One end of the CSST should be plugged, and each hole sequentially plugged (with modeling clay) until the CSST no longer leaks. One of the holes we found in a CSST investigation was in an area of tubing where the polymer coating had no fire damage, as shown in Figure 7. In Figure 8 we see a microscopic view of this small leak (three other holes on this same length of CSST occurred in areas where heavy pyrolysis to the coating had occurred). As in any fire investigation, the leaks and subsequent fire development must support the area of origin, or the leaks would appear to be of little consequence.

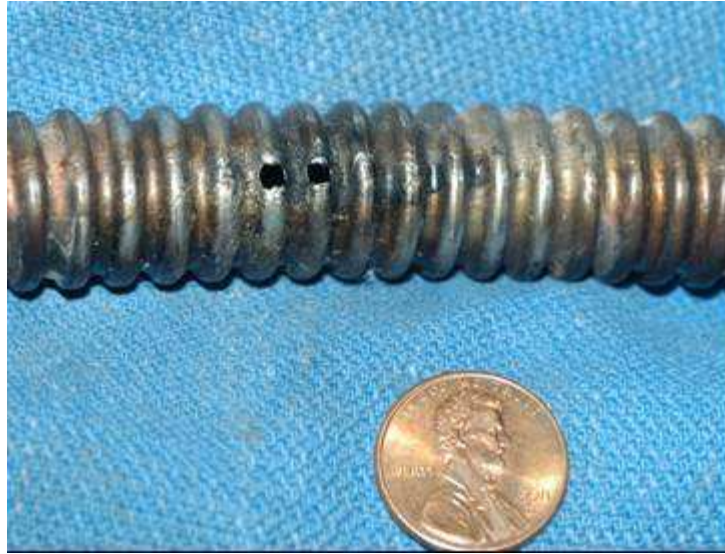
Figure 10: Adjacent perforations in CSST

Figure 10 shows a length of CSST in which there were two perforations in adjacent furrows of the tubing. We have seen as many as 4 holes in one CSST length after a fire.
