REDUCING THE FIRE HAZARD

IN ALUMINUM-WIRED HOMES

Jesse Aronstein, PH.D., P.E.

Latest update: May 21, 2007

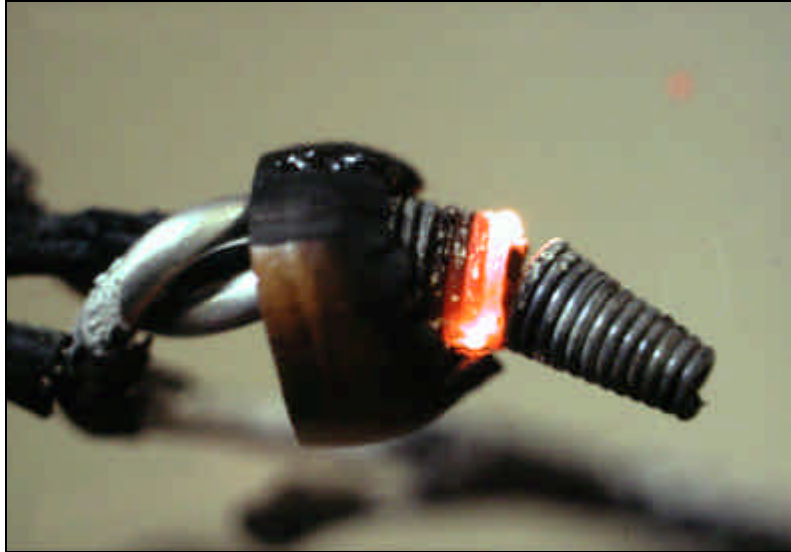
FIGURE 1 - ALUMINUM WIRE SPLICES MADE WITH TWIST-ON CONNECTORS CAN BE DANGEROUS. The use of most types of twist-on connectors with aluminum wire can lead to hazardous results. This twist-on pigtail connection (two #10 aluminum wires with one #12 copper wire, in a 20-amp circuit), made with a twist-on connector that was UL listed for use with aluminum wire at the time, remains electrically functional in the circuit, but it becomes extremely hot whenever a significant amount of current flows. The heat has deteriorated the insulation on both the connector and the wires. In this photo, a portion of the connector's spring is red hot, at current well below the circuit rating.

The most certain corrective action for all cases would be to rewire the home with copper wire. This is expensive and impractical in most cases. A practical approximation to rewiring can be achieved by a method known as "pigtailing", using a specially-selected connector and installation method to splice a short length of solid copper wire to each aluminum wire end. The copper wire "pigtail" is then connected to the circuit breaker, light fixture, receptacle, dishwasher, or other termination. This method is only effective if the connections between the aluminum wires and the copper pigtails are extremely reliable. Pigtailing with some types of connectors, even though they might be presently listed by UL or certified by CSA for the application, can lead to increasing the hazard.[5][6] (See Figure 1.)

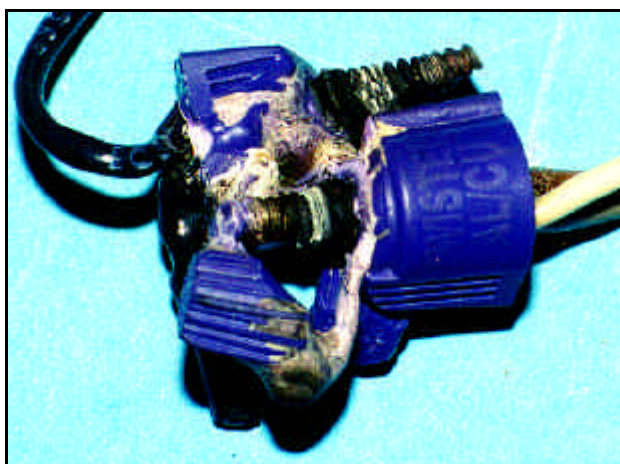
A. THESE TWO FAILED SPLICES ARE ADHERED TOGETHER BY THE MELTED PLASTIC SHELLS

FIGURE 5 - FIELD FAILURES OF ALUMINUM TO COPPER SPLICES MADE WITH IDEAL #65 CONNECTORS [12]

Additionally, field burnouts have now been reported with the Ideal #65 connectors in their rated applications. With CPSC skeptical (and requesting that UL withdraw its listing), the manufacturer initially agreeing that the connector is not for the pigtailling retrofit application, independent tests clearly demonstrating poor performance, and field failures reported, the use of the Ideal #65 "Twister" connector for the pigtailling application is definitely not recommended. If the COPALUM repair is not available, use the AlumiConn connector (See Section 1C).

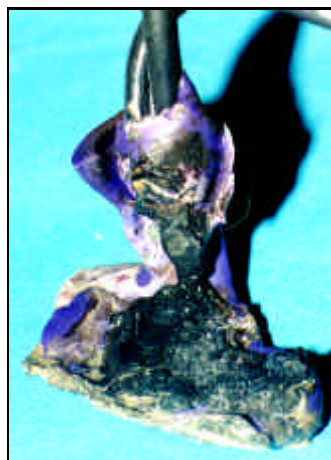
B. SEVERE FAILURE, PLASTIC SHELL MELTED AND CHARRED. THE CHARRING INDICATES THAT IT HAD PROBABLY IGNITED.
