REDUCING THE FIRE HAZARD

IN ALUMINUM-WIRED HOMES

Jesse Aronstein, PH.D., P.E.

Latest update: May 21, 2007

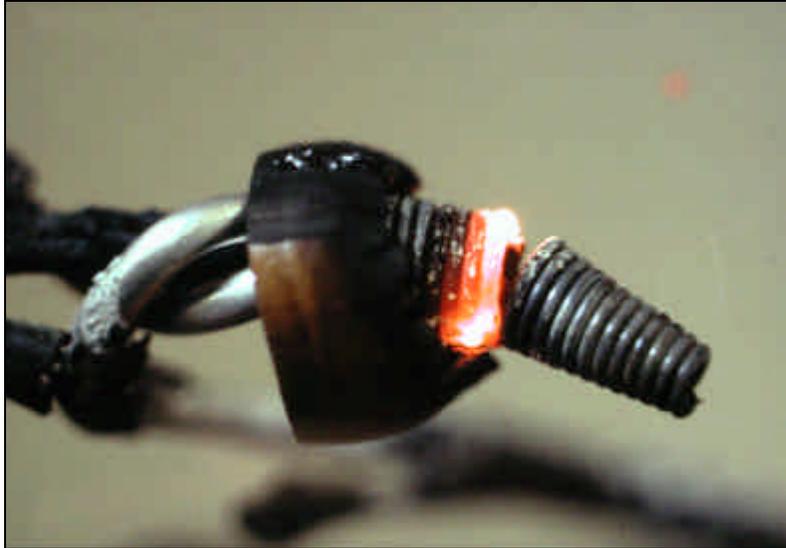
FIGURE 1 - ALUMINUM WIRE SPLICES MADE WITH TWIST-ON CONNECTORS CAN BE DANGEROUS. The use of most types of twist-on connectors with aluminum wire can lead to hazardous results. This twist-on pigtail connection (two #10 aluminum wires with one #12 copper wire, in a 20-amp circuit), made with a twist-on connector that was UL listed for use with aluminum wire at the time, remains electrically functional in the circuit, but it becomes extremely hot whenever a significant amount of current flows. The heat has deteriorated the insulation on both the connector and the wires. In this photo, a portion of the connector's spring is red hot, at current well below the circuit rating.

The most certain corrective action for all cases would be to rewire the home with copper wire. This is expensive and impractical in most cases. A practical approximation to rewiring can be achieved by a method known as "pigtailling", using a specially-selected connector and installation method to splice a short length of solid copper wire to each aluminum wire end. The copper wire "pigtail" is then connected to the circuit breaker, light fixture, receptacle, dishwasher, or other termination. This method is only effective if the connections between the aluminum wires and the copper pigtails are extremely reliable. Pigtailling with some types of connectors, even though they might be presently listed by UL or certified by CSA for the application, can lead to increasing the hazard.[5][6] (See Figure 1.)

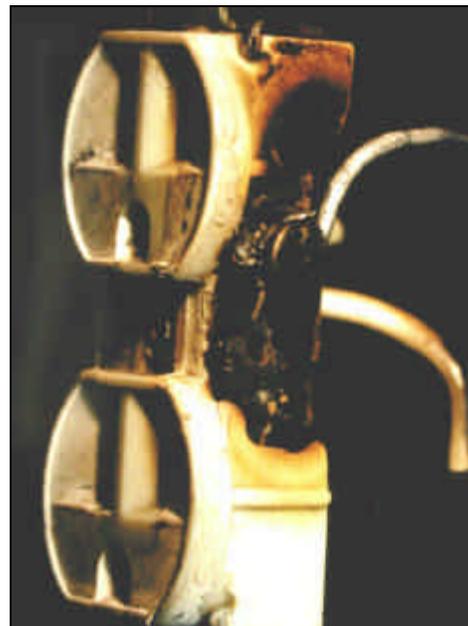
FIGURE 2 - EXAMPLE OF OVERHEATING OF ALUMINUM-WIRED TERMINALS ON A RECEPTACLE. Enough heat was generated by current flowing through the aluminum wire connections to cause charring of the receptacle body and disintegration of the insulation that was on the wire. Note that the face of the receptacle, as the homeowner or an inspector would have seen it, with the cover plate on, would look normal.

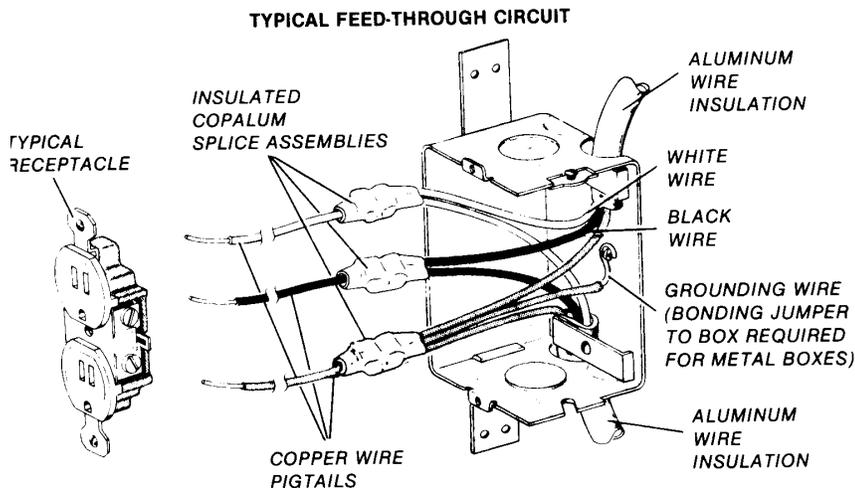
**FIGURE 3 - Illustration of copper wire pigtailed to aluminum circuit wires using AMP* (Tyco) COPALUM connectors
(Source: U.S. Consumer Product Safety Commission)**

Repair by pigtailing, using COPALUM connectors installed by a qualified electrician, is the only method considered by the U.S. consumer Product Safety Commission ("CPSC") to be a permanent repair. Their recommendation is based on extensive testing. The method is described in more detail, and sources for more information are provided in an article in Consumer Reports, January 1981.[7] While the application of COPALUM connectors is considered to be satisfactory without special preparation of the aluminum conductor, it is suggested that antioxidant compound and abrasion as per Section 1A (above) be used to provide an additional safety factor.

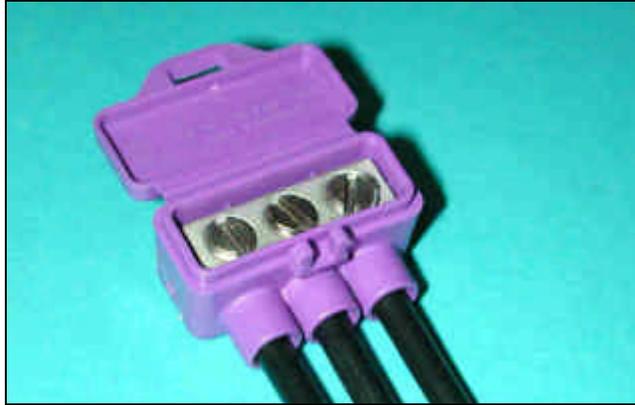
FIGURE 4 - King Innovation "AlumiConn" Connector

On the basis of the test results, the AlumiConn connector is predicted to have a high probability of failure-free long-term safe performance, PROVIDED THAT THE SETSCREWS ARE CAREFULLY TIGHTENED TO THE MANUFACTURER'S RECOMMENDATION (see notes below). If not tightened to the manufacturer's recommendation, there is a possibility that the connections will degrade due to wire stresses and/or motion when the completed connection is manipulated into the outlet (or junction) box.

1. The manufacturer's instructions provide two alternative methods for tightening. Either (instruction card, item #3 or 3A) may be used.
2. It is difficult to properly tighten the setscrews if the connector is hand-held. The connector needs to be held in a tool while tightening. The manufacturer has indicated that some electricians are using "channel-lock" type pliers for this purpose. A special holding tool may be developed and made available by the connector manufacturer.

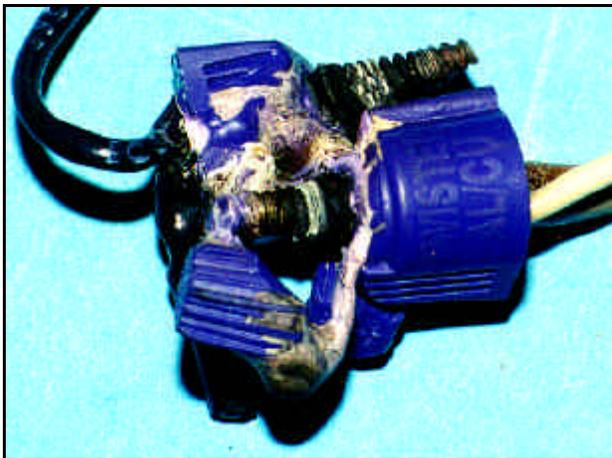
FIGURE 5 - FIELD FAILURES OF ALUMINUM TO COPPER SPLICES MADE WITH IDEAL #65 CONNECTORS [12]

A. THESE TWO FAILED SPLICES ARE ADHERED TOGETHER BY THE MELTED PLASTIC SHELLS

3. IDEAL #65: came on the market in the mid-1990's. Within three years of its introduction, the first report of field failure surfaced. There have been additional failures reported since then.

Additionally, field burnouts have now been reported with the Ideal #65 connectors in their rated applications. With CPSC skeptical (and requesting that UL withdraw its listing), the manufacturer initially agreeing that the connector is not for the pigtailling retrofit application, independent tests clearly demonstrating poor performance, and field failures reported, the use of the Ideal #65 "Twister" connector for the pigtailling application is definitely not recommended. If the COPALUM repair is not available, use the AlumiConn connector (See Section 1C).

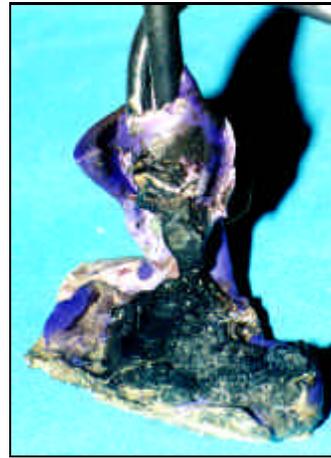
B. SEVERE FAILURE, PLASTIC SHELL MELTED AND CHARRED. THE CHARRING INDICATES THAT IT HAD PROBABLY IGNITED.
