INVESTIGATING THE CAUSAL LINK BETWEEN LIGHTNING STRIKES, CSST AND FIRE

Mark Goodson PE
Mark Hergenrether, MSME

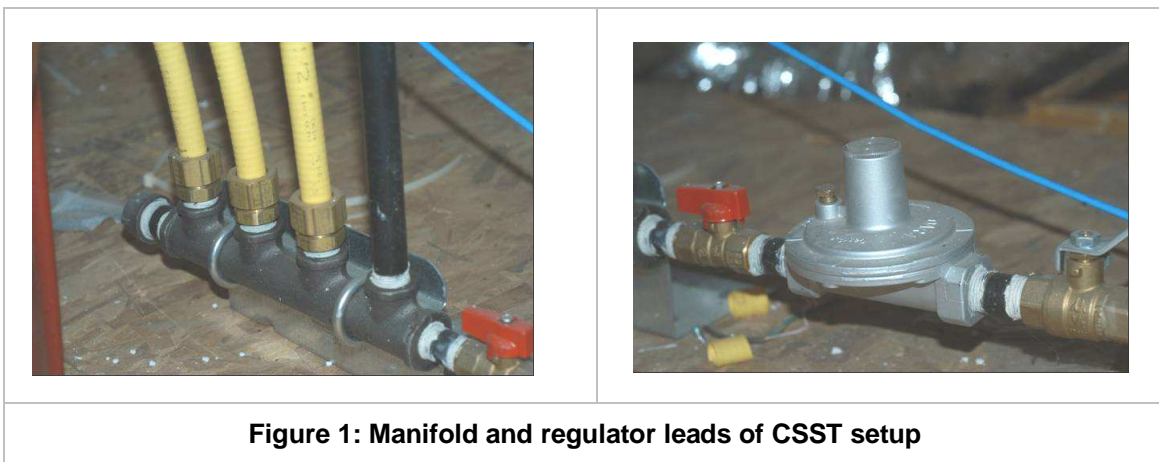
CSST is different from black pipe in a number of ways. On a CSST system, gas enters a house at about 2 psi, and is dropped to ~ 7" WC by a regulator in the attic (assuming NG and not propane). The gas then enters a manifold and is distributed via 'home runs' to each separate appliance. Unlike black pipe, a CSST system requires one separate run for each appliance. (See Figure 1 for a typical manifold) As an example, a large furnace and 2 water heaters in a utility closet will require 3 separate CSST runs from the manifold; with black pipe, the plumber may have just used 1 run of 1" pipe and then teed off in the utility room. The reality of this design is that now there is a tubing system carrying 2 psi of NG in the residence, and 3 separate runs (1 for each appliance).
