U.S. Department of Housing and Urban Development
Office of Policy Development and Research

***WATER INTRUSION EVALUATION
FOR CAULKLESS SIDING,
WINDOW, AND DOOR SYSTEMS
WATER INTRUSION - LABORATORY TESTING RESULTS***

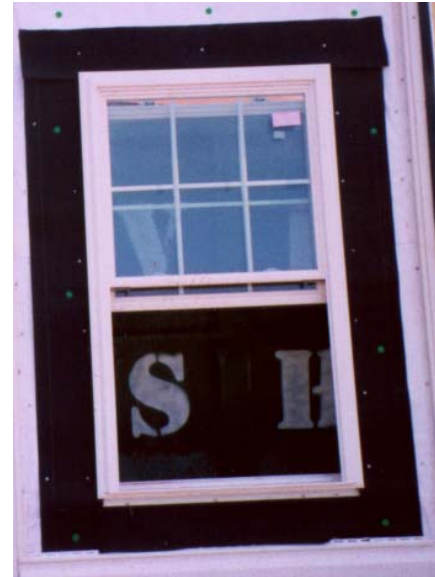
Test walls were constructed using best construction practices; studs on 24-inch centers, 7/16-inch oriented strand board (OSB) sheathing, exterior weather barrier and flange-mounted welded vinyl windows equipped with integral j-channels. Careful attention was paid to head, sill, and side flashing details. This was accomplished with 10-inch wide strips of 30-pound building felt attached with button-cap nails (see Figure 3). The bottom flashing was installed before the window so that the framing could be protected. Next, the window was installed. The window flanges were set in 100 percent silicon caulk. The side flashing was then installed so that it covered the window flange and overlapped the bottom flashing. Finally, a slit was cut in the weather barrier above the window. The felt flashing was inserted under the weather barrier and over the top window flange and side flashings. With the exception of the caulkless fiber cement test wall, the siding was installed as per manufacturer specifications.

Figure 3
Flashing Detail

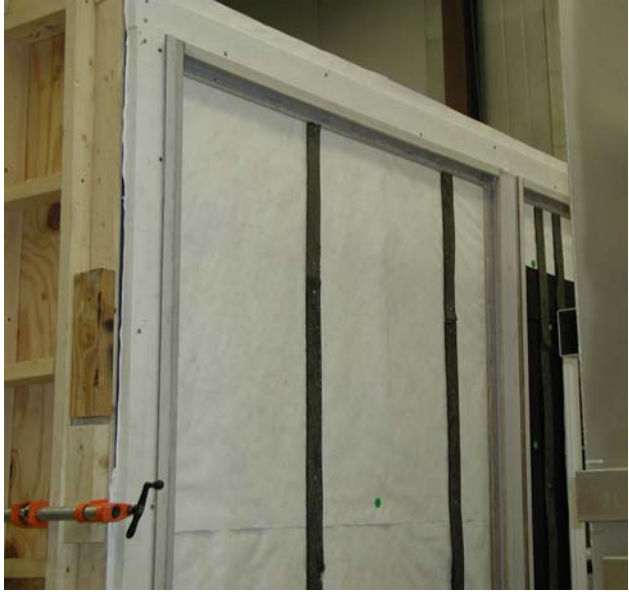
The caulkless fiber cement test walls utilized wood fiber/plastic composite corner posts and j-channels. These components are dimensionally and functionally very similar to vinyl siding corners and j-channel (Figure 4). When fiber cement manufacturers were consulted as to the feasibility of the caulkless system, they had several concerns. Their primary concerns were that the siding would absorb water through unprimed end cuts within the corner posts or j-channel. To address these concerns, several of the cut ends were protected with snap-on vinyl end treatments (Figure 5). Several other ends were not protected so that a comparison could be made.

Figure 4
Drainage Plane

Two, 2-inch wide strips of fiberglass composition roofing shingles, fastened with roofing nails, were used to form a 1/4-inch deep drainage plane (see Figure 4) for the fiber cement caulkless system with an airgap.

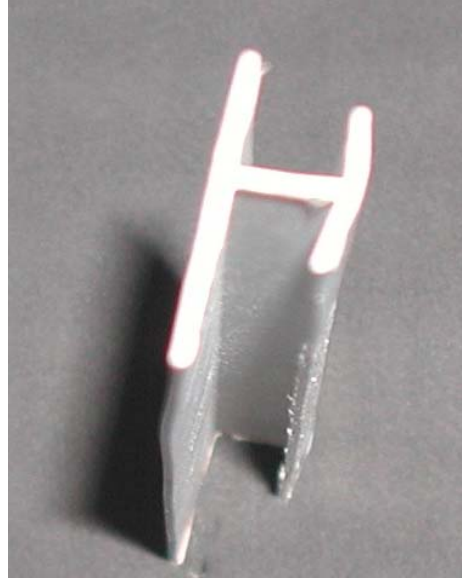
Figure 5
Vinyl Edge Protector

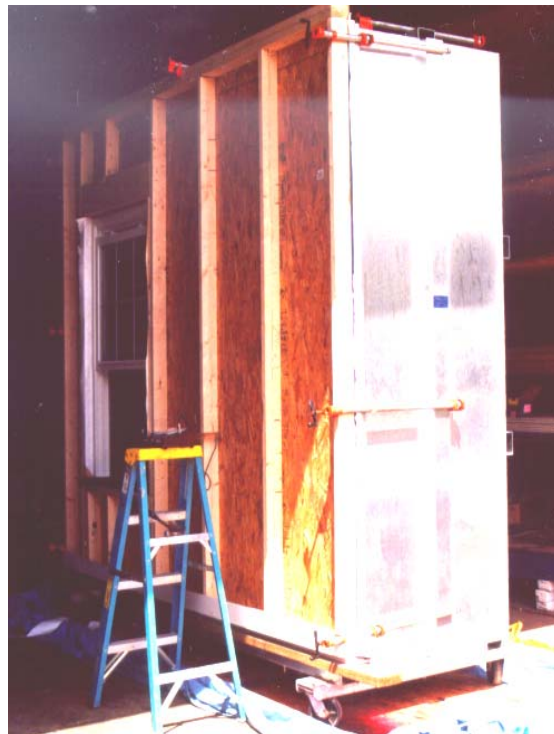
Once constructed, the test walls were inserted in the test chamber using a foam gasket to prevent leakage during the evaluation period (Figure 6).

Figure 6
Wall Secured in Test Chamber

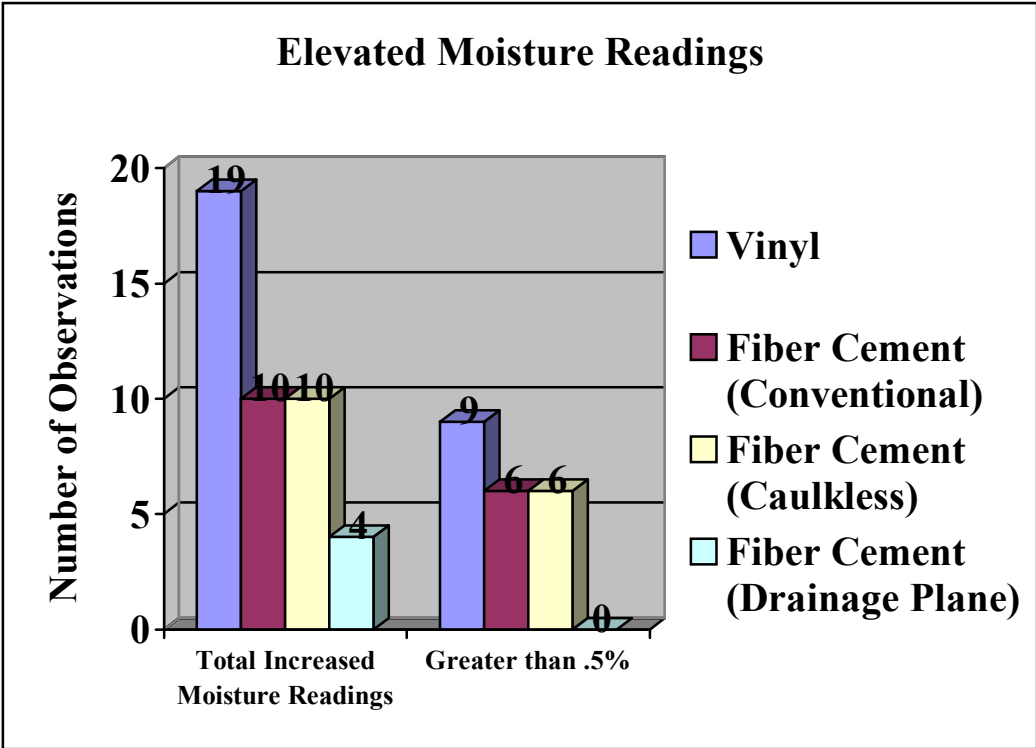
Table 2 presents the moisture readings before and after the testing. The negative changes recorded were most likely the result of areas that did not get wet during testing drying out overnight. Figure 7 provides a summary of the elevated moisture readings. The total increased moisture readings include all elevated moisture readings. The readings above .5 percent were separated to exclude those readings within the error potential for the measuring equipment. The vast majority of the readings showed no elevation in moisture levels. By referring to Table 2 and Figure 2, it can be determined that about a third of the elevated moisture readings occurred near the window opening and well over half occurred on the bottom half of the specimen. However, the number of elevated readings and their degree suggest the flashing systems performed adequately. This reinforces the fact that windows and other penetrations are the most susceptible to water intrusion and absorption.

Figure 7
Summary of Elevated Moisture Readings

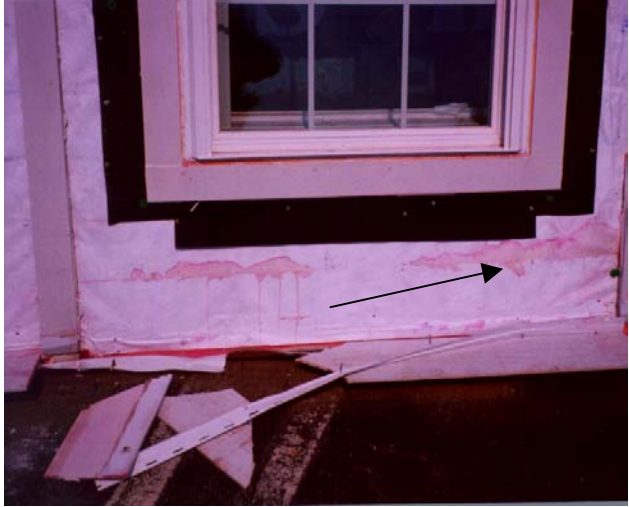
Visual inspection indicated that water penetrated to varying extents at the majority of the caulk joints. However, the majority of water intrusion appears to have occurred through the bottom of the laps of siding (Figures 10 and 11). This leakage path was more pronounced in this specimen when compared to either of the caulkless specimens (Figure 12). It is possible that the pressure difference between the front and backside of the siding was influenced by the caulk sealed areas. This could cause a greater pressure differential and concentration of air flow through less crack length areas. The high pressure difference and airflow rate could explain why water traveled up and over the siding laps. This would explain why this phenomenon did not occur on the caulkless systems.

Figure 10
Conventional Fiber Cement Specimen - Window

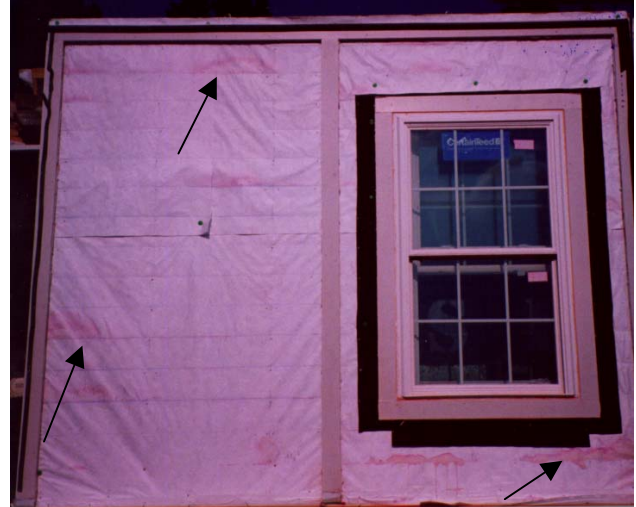
Figure 11
Conventional Fiber Cement Specimen - Clear Wall

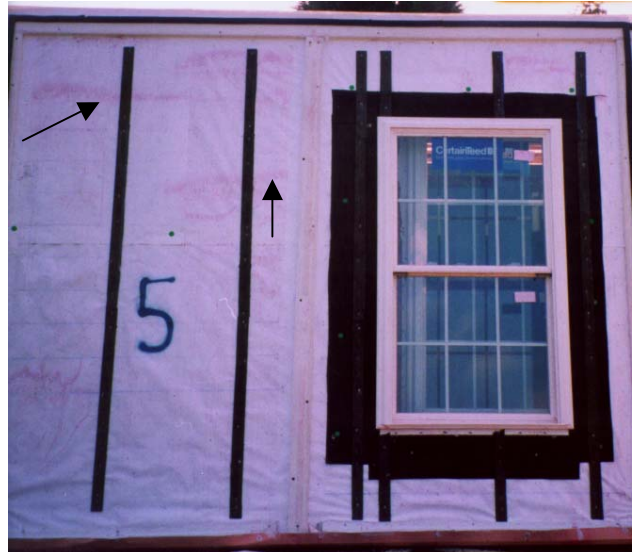
Both of the caulkless fiber cement samples performed very similar to the vinyl sided specimen. As with the vinyl sample, the corner posts and j-channel had significant vertical streaking (Figures 13 and 14). The vertical streaking indicates an unimpeded flow of water out of the wall system. This was expected on the specimen with the drainage plane, but not necessarily of the specimen without the drainage plane. The 1/4-inch-thick composite cornerpost and j-channel

Figure 14
Fiber Cement with Drainage Plane

appear to have created adequate separation at the edge details between the siding and weather barrier to allow the water to move freely.
